# **TRIAL DREDGING REPORT**

**Anchorage Harbor Deepening**  
**Port of Anchorage, Alaska**

**November 2008**

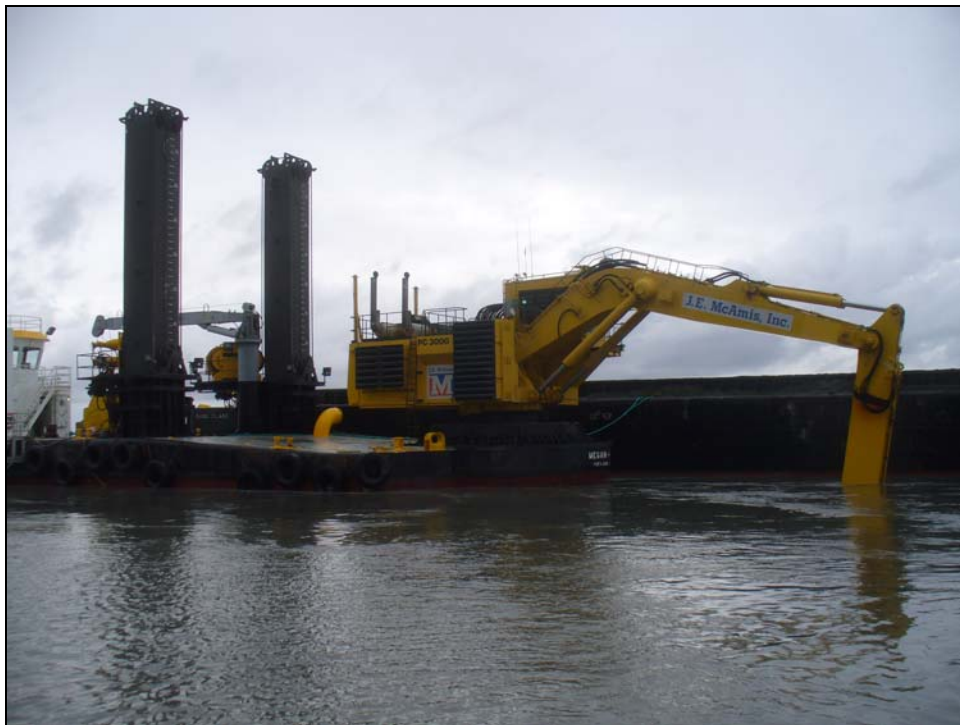
Photograph 1: McAmis's Megan-Renee dredging barge and Komatsu PC3000 Aquadigger.

On 17 July 2008, J.E. McAmis used the Megan-Renee dredging barge and its Komatsu PC3000 Aquadigger excavator to dredge in the northern virgin dredge area near the location of test boring AP-4607. The Megan-Renee dredging barge was equipped with three 95-foot spuds to keep the barge in place while dredging. The excavator had a 10-cubic yard bucket and an approximate digging capability of 65 feet below the barge deck. Photograph 1 shows the barge and backhoe working at trial dredge area 1. Additional photographs of the McAmis dredging operations are presented in Appendix D.

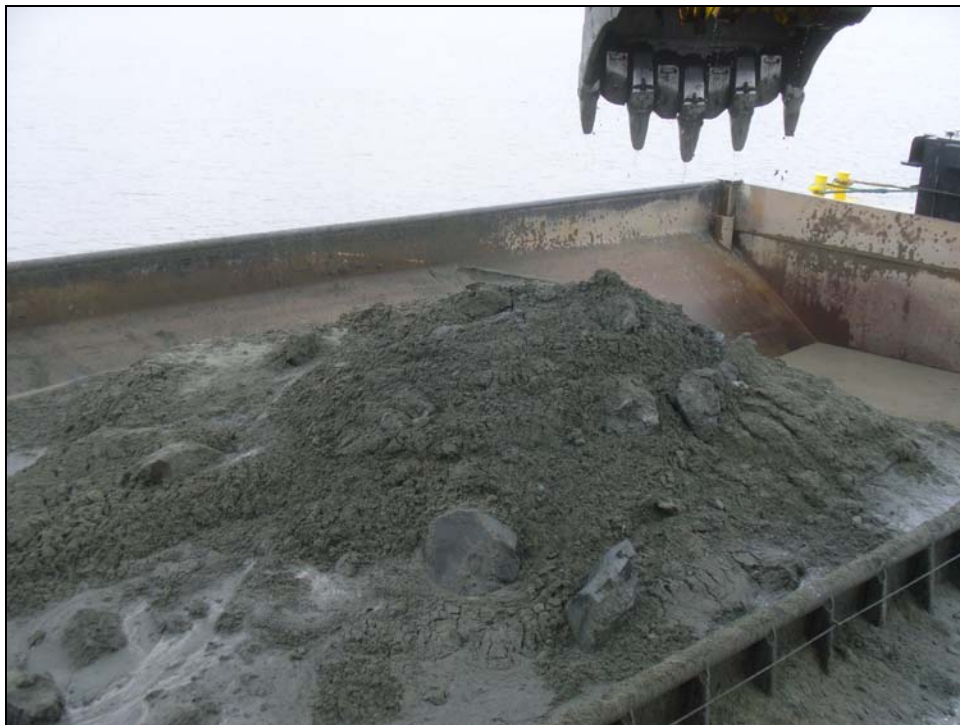
Photograph 2: Example of sand with silt (SP-SM) containing cobbles and boulders encountered at trial dredge area 1 (AP-4607).

McAmis's crew worked two 12-hour shifts at this location and dredged a total volume of approximately 7,940 cubic yards of material. Dredged material was loaded into the Sand Island split-barge dump scow and taken to the approved off-shore disposal site. The surface layer of gravel with silt, sand, and cobbles (GP-GM) was initially very difficult to break through. The volume of cobbles was estimated at 10 percent or less within this soil layer during the trial dredging. Sand with silt (SP-SM) was encountered below the surface layer of gravel. Photograph 2 shows an example of this soil unit encountered while dredging. The estimated yield of material dredged in each 10-cubic yard bucket was between 80 to 100 percent (8 to 10 cubic yards in a 10-cubic yard bucket). After a large dredging area was established, the side slopes of the excavation in the very dense sands with silt (SP-SM) began to slough to a limited extent into the area being excavated. Below the approximate elevation of -40 feet MLLW occasional layers of lean clay (CL) were encountered while dredging.

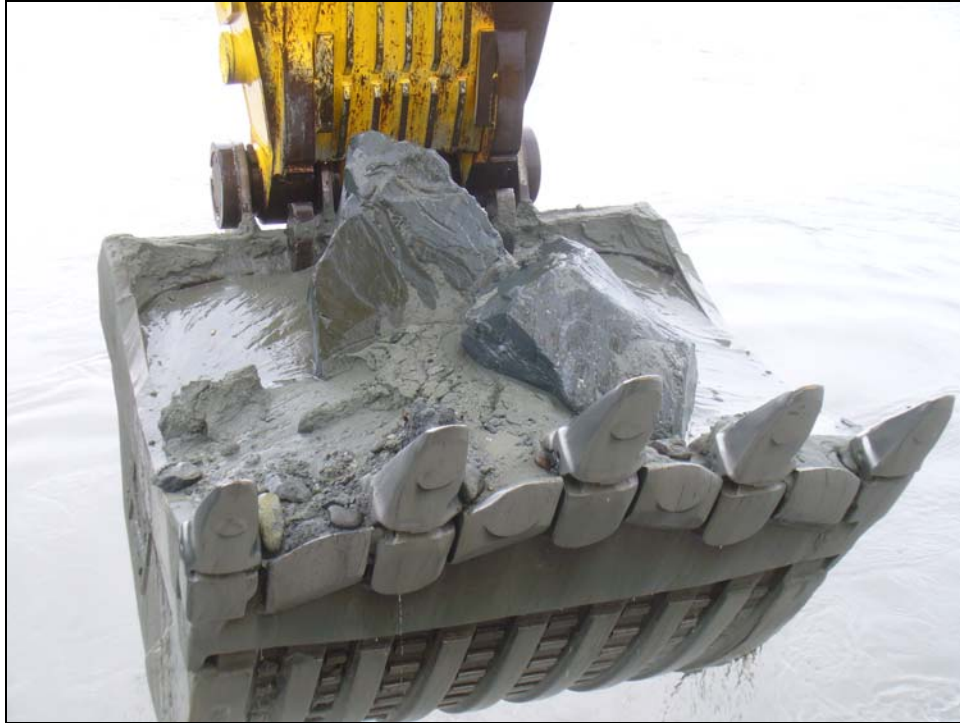
Photograph 3: Boulders and cobbles encountered while dredging at trial dredge area 1 (AP-4607).

Boulders with a maximum dimension of six feet were encountered in trial dredge area 1. The estimated volume of boulders encountered while dredging was five percent or less. Photographs 2, 3, and 4 provide an example of the boulders encountered while dredging. This confirms that boulders are present within the proposed new work dredging areas. Survey information collected after the trial dredging was completed is provided in the Appendix B.

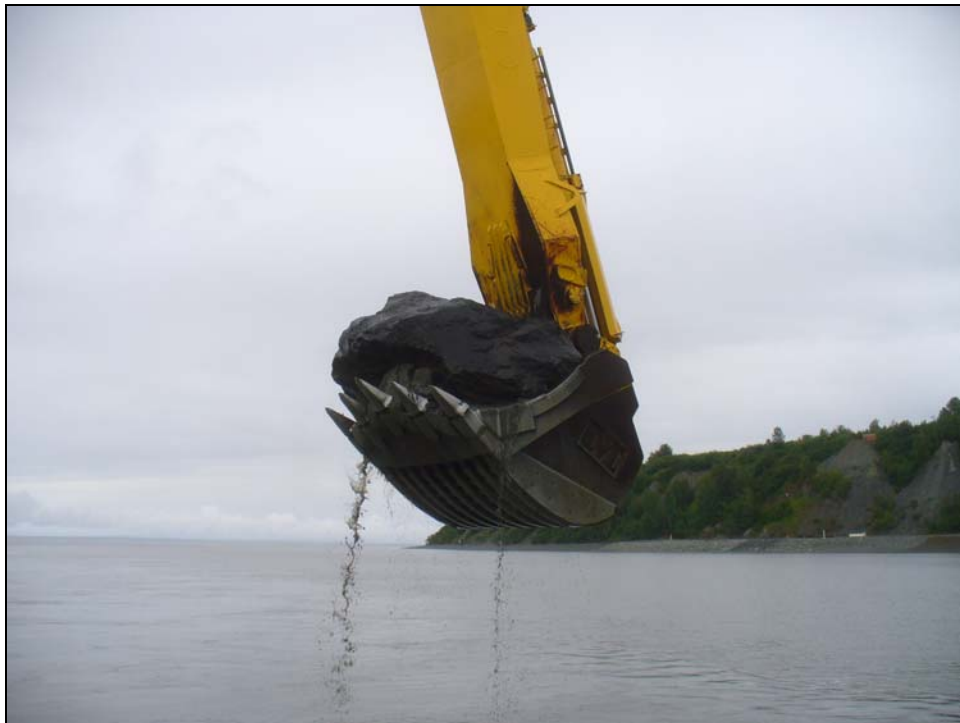
Photograph 4: Six-foot diameter boulder encountered while dredging at trial dredge area 1 (AP-4607).

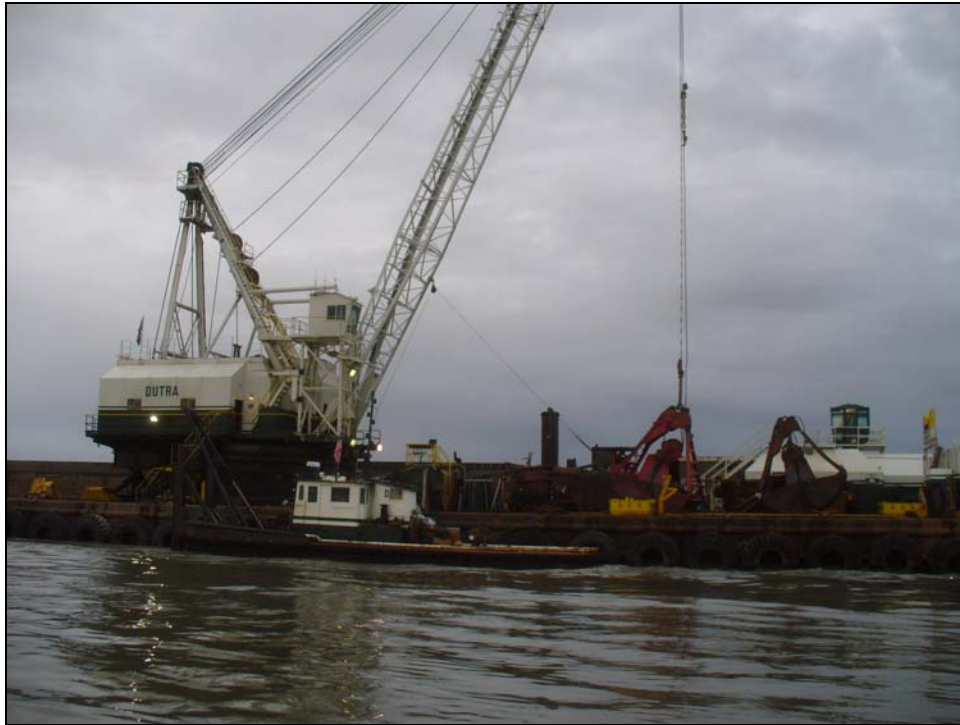
Photograph 5: Dutra's Paula Lee dredging barge and crane.

On 16 September 2008, The Dutra Dredging Company used the Paula Lee dredging barge with a crane and clam shell bucket to dredge in the southern virgin dredge near the location of test boring AP-4611. Photograph 5 shows the Paula Lee dredging barge and crane. Additional photographs of the Dutra dredging operations are presented in the Appendix D.

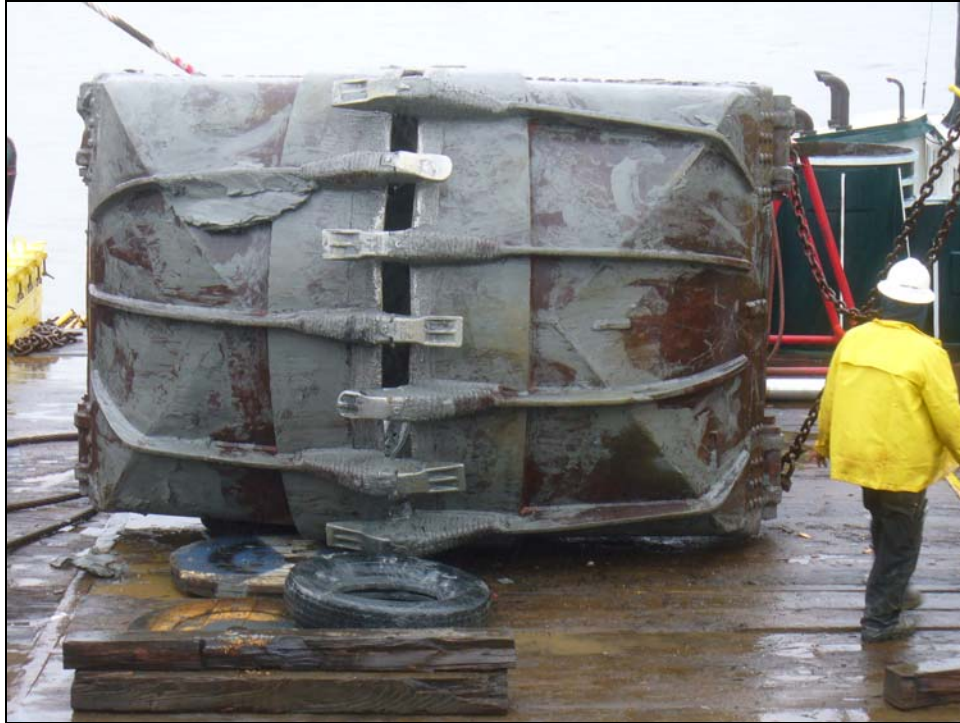
Photograph 6: View of 10-cubic yard Owens clam-shell bucket weighing 54,000 pounds.

The Paula Lee dredging barge was equipped with two spuds and four anchors to keep the barge in place while dredging. Dutra's crew worked approximately 18 hours at this location and dredged a total volume of approximately 3,400 cubic yards of material. Dredged material was loaded into the split-barge Scow No. 5 and taken to the approved off-shore disposal site. Initially a 20-cubic yard Atlas clam-shell bucket weighing 30,000 pounds was used to remove the soft marine deposits of silt and silty sand (ML, SM) at the surface. The wet density of this soil was measured at 118.2 pounds per cubic foot. After the surface layer of soft or loose soils was removed, a 10-cubic yard Owens clam-shell bucket, weighing 54,000 pounds, was used to dredge the very dense clayey gravel with sand and cobbles (GC) encountered below the recent marine deposits. Photograph 6 shows the Owens 10-cubic yard bucket. Dredging the very dense clayey gravel with sand, cobbles, and boulders (GC) proved difficult; the material recovered from each effort with the 10-cubic yard bucket was low with an estimated yield of 30 to 50 percent.

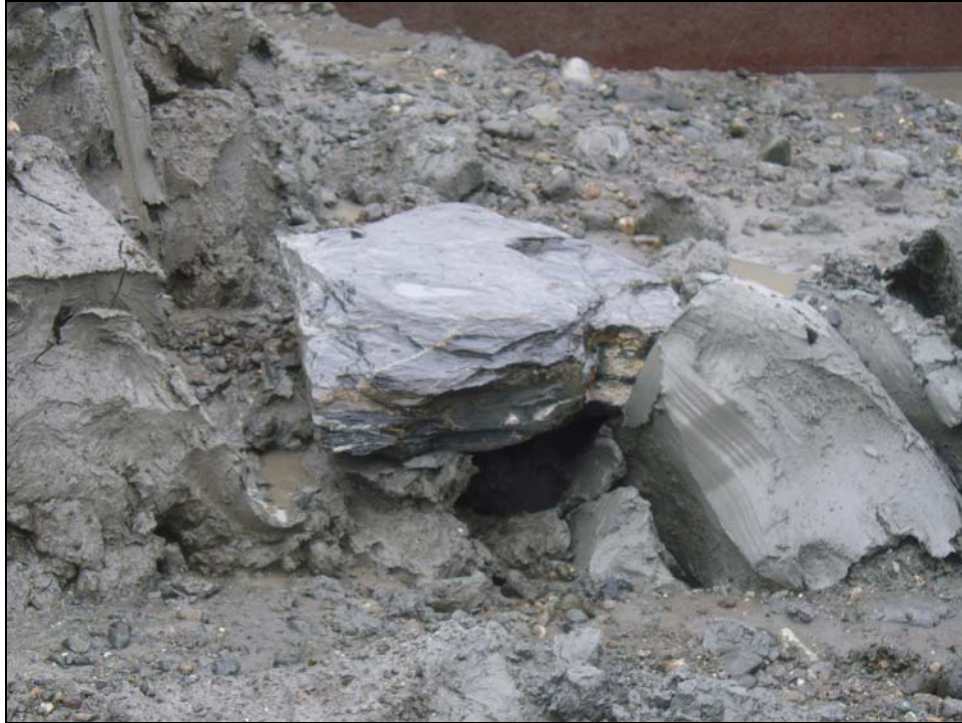
Photograph 7: Boulder encountered while dredging near elevation -25 feet MLLW at trial dredge area 2 (AP-4611).

The wet density of this soil was measured at 128.6 pounds per cubic foot. The estimated volume of cobbles was 10 percent or less within this soil layer. A boulder with the approximate dimensions of 2 feet wide, 3 feet long, and 1 foot thick was dredged near elevation -25 feet MLLW. This boulder, shown in Photograph 7, had angular and fresh fractured faces indicating it was only a portion of a larger boulder. Firm lean clay (CL) was encountered below approximate elevation -28 feet MLLW. The wet density of this material was measured at 123.8 and 115.6 pounds per cubic foot. The material recovered during each effort with the 10-cubic yard bucket increased in the clay soils to an estimated yield of 70 to 100 percent. There was no difficulty in emptying the bucket and releasing the lean clay into the dump scow. The dredge area side slopes within the clay soils did not appear to slough while dredging. Photograph 8 shows the lean clay encountered below -28 feet MLLW.

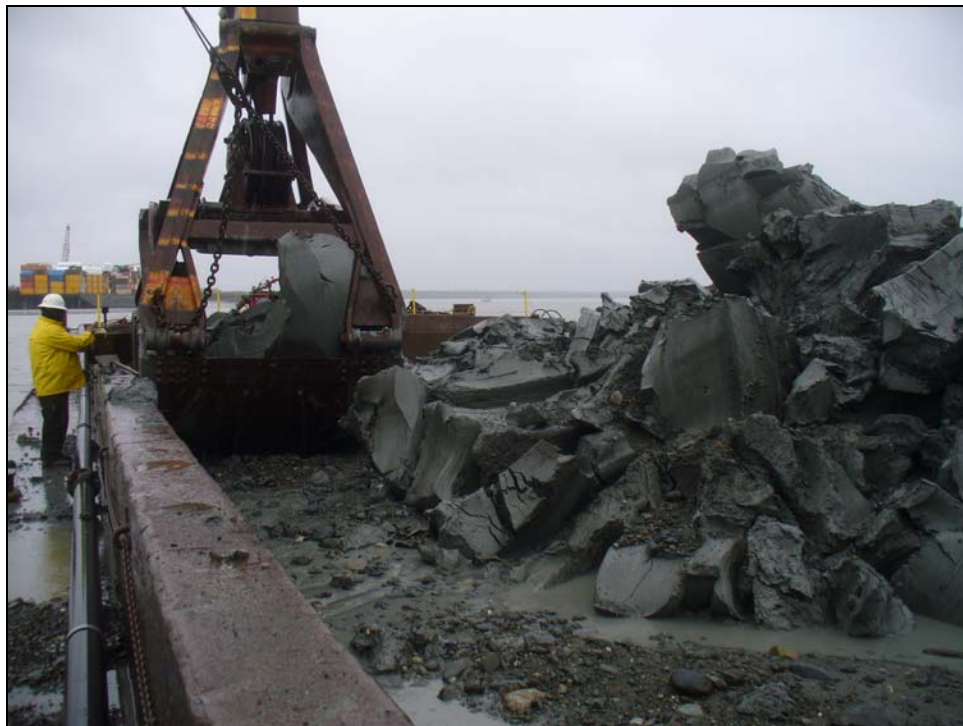
Photograph 8: Firm lean clay (CL) encountered below approximate elevation -28 feet MLLW while dredging at trial dredge area 2 (AP-4611).

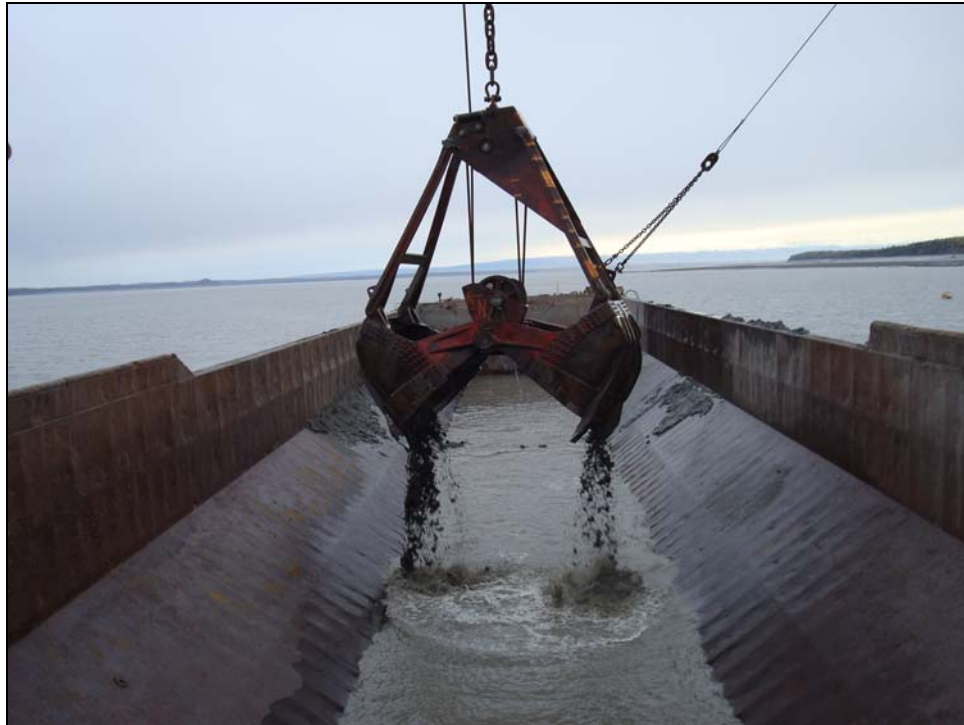
Photograph 9: Example of low material recovery using the 10-cubic yard Owens bucket while dredging near the surface at trial dredge area 3 (AP-4590).

On 23 September 2008, Dutra dredged near the location of test boring AP-4590 in the northern virgin dredge area. Dutra's crew worked two 12-hour shifts at this location and dredged a total volume of approximately 2,000 cubic yards of material. Dredged material was loaded into the split-barge Scow No. 5 and taken to the approved off-shore disposal site. Dredging was very difficult; initially the 20-cubic yard Atlas clam-shell bucket, weighing 30,000 pounds, was used with little or no recovery of material. This bucket was immediately replaced with the 10-cubic yard Owens clam-shell bucket weighing 54,000 pounds. The volume of material recovered from each 10-cubic yard bucket was very low with an estimated yield of 10 percent or less. Photograph 9 shows the typical amount of material recovered just below mud line. The wet density of gravel with silt, sand, and cobbles (GP-GM) encountered near the surface was measured at 148.4 pounds per cubic foot. The volume of cobbles at this location was estimated at 10 percent or less within this soil layer.

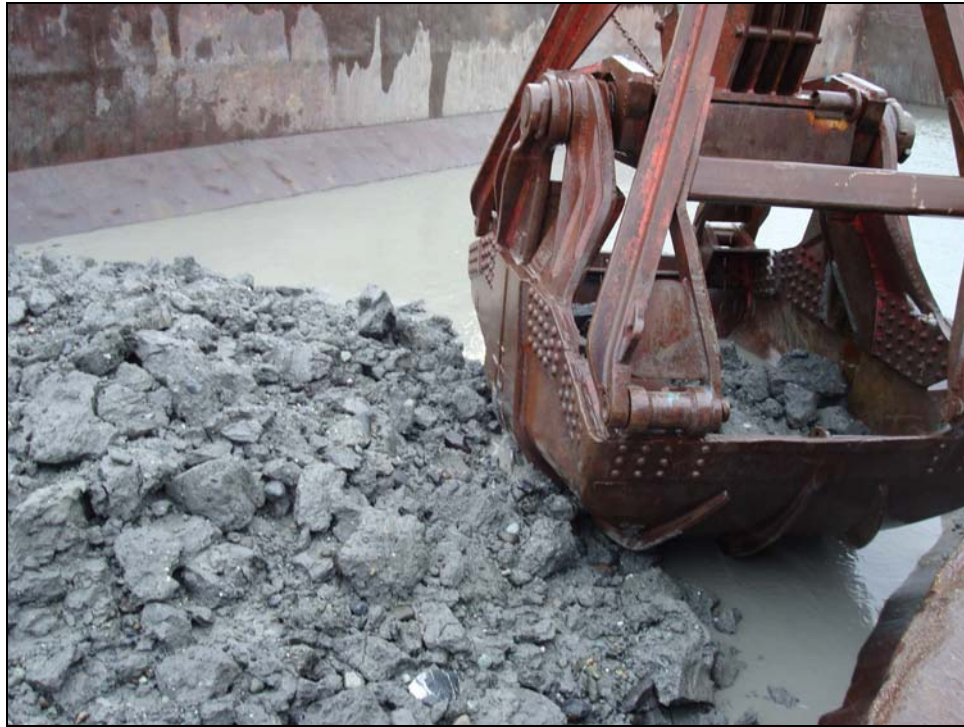
Photograph 10: An example of clayey gravel (GC) and/or clayey sand (SC) dredged at trial dredge area 3 (AP-4590). Note the amount of material recovered in a typical pass with the 10-cubic yard Owens bucket.

The material recovered from each bucket did increase with depth to an estimated yield between 10 and 40 percent. Photograph 10 shows an example of clayey gravel (GC) and clayey sand (SC) and the typical amount of material recovered using the 10-cubic yard Owens bucket. The dredge area side slopes within these soils did not appear to slough while dredging. Survey information collected after the trial dredging was completed is provided in Appendix C.

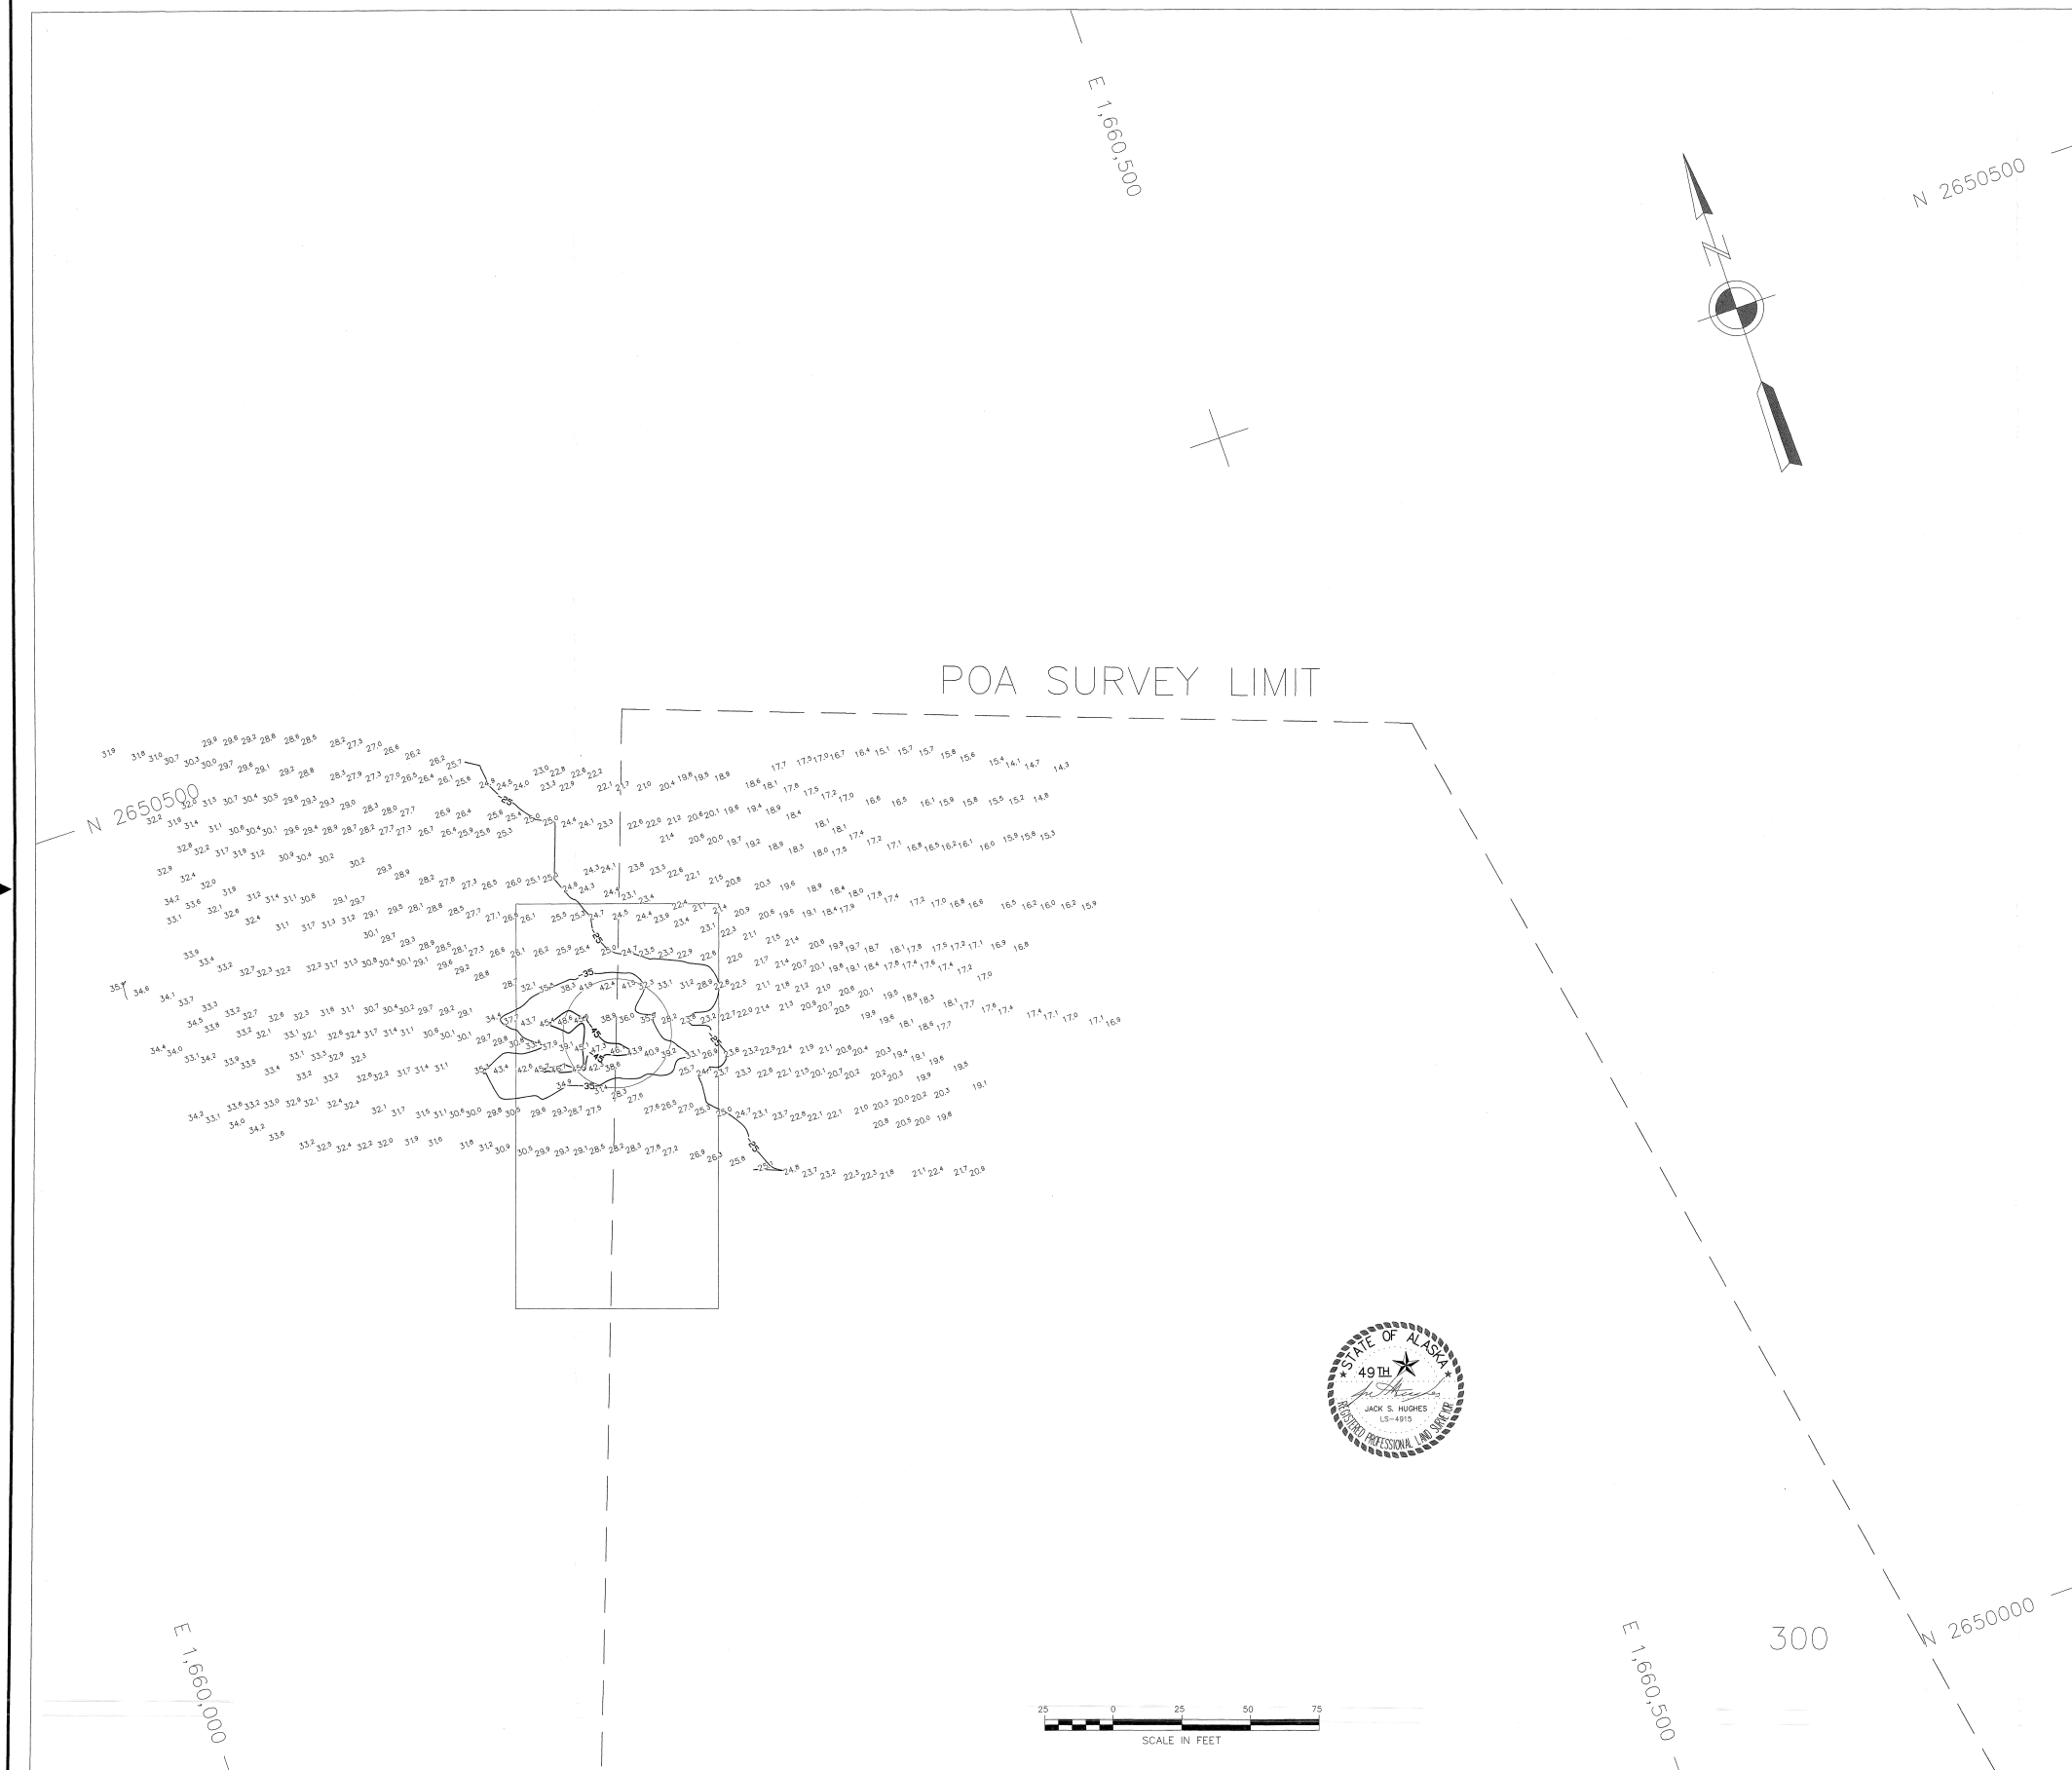
3. SOUNDINGS WERE CONDUCTED ON SEPTEMBER 24, 2008 USING AN INSPERPAGE 448 SINGLE BEAM ECHO SOUNDER WITH A 200KHZ, 3 DEGREE BEAM-WIDTH TRANSDUCER, SOUNDVELOCITY THROUGH THE WATER COLUMN WAS DETERMINED USING AN ODEM DIGIBAR PRO AND A CONVENTIONAL 60" BAR CHECK. TIDE CORRECTION WERE PROVIDED BY A TRIMBLE 5700 RTK RECEIVER AND CHECKED BY CONVENTIONAL LEVELING METHODS.

4. HORIZONTAL POSITIONING WAS PROVIDED USING A TRIMBLE 5700 RECEIVER OPERATING WITH RTK CORRECTIONS BEING BROADCASTED FROM A TRIMBLE 5700 BASE STATION AT USACE SBC "S, END, 1978".

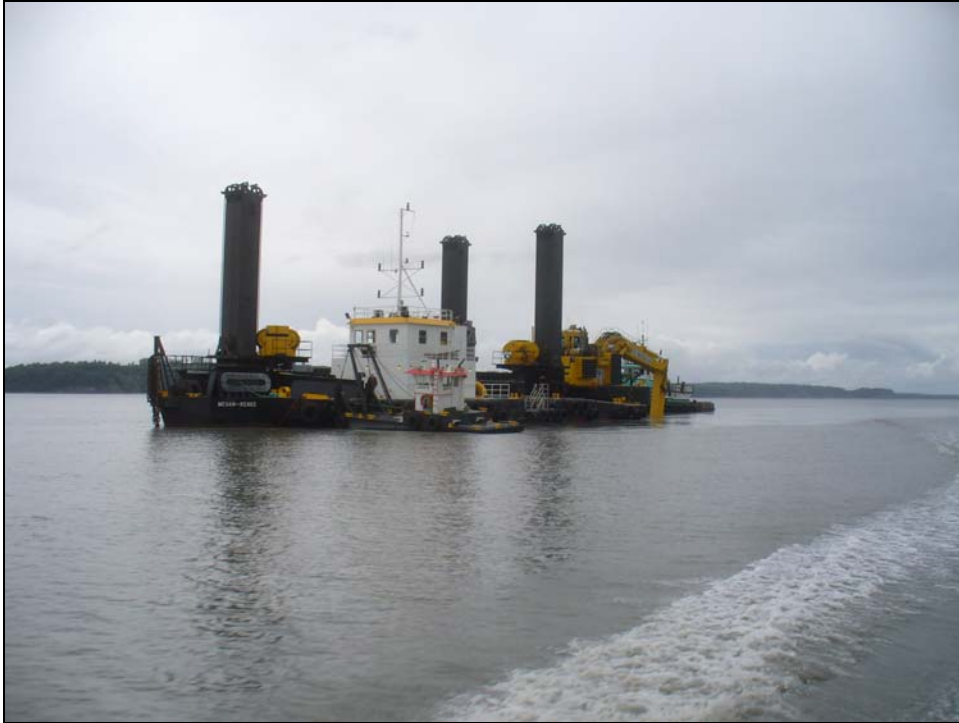
Photograph 11: McAmis's Megan-Renee dredging barge at trial dredge area 1 (AP-4607).

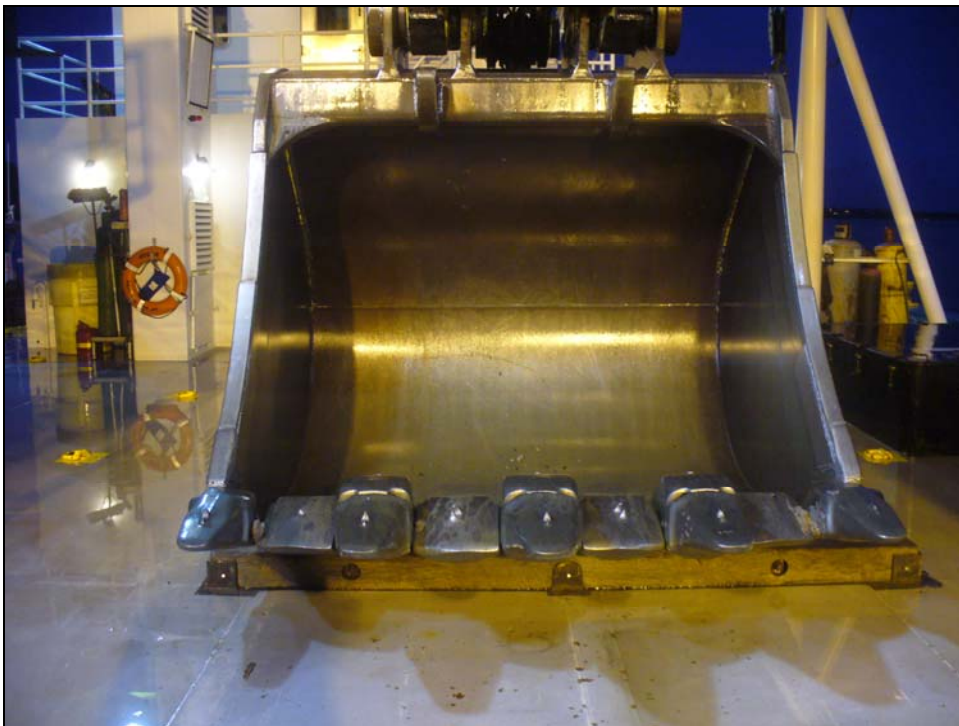
Photograph 12: McAmis's 10-cubic yard bucket used by the Komatsu PC3000 Aquadigger.

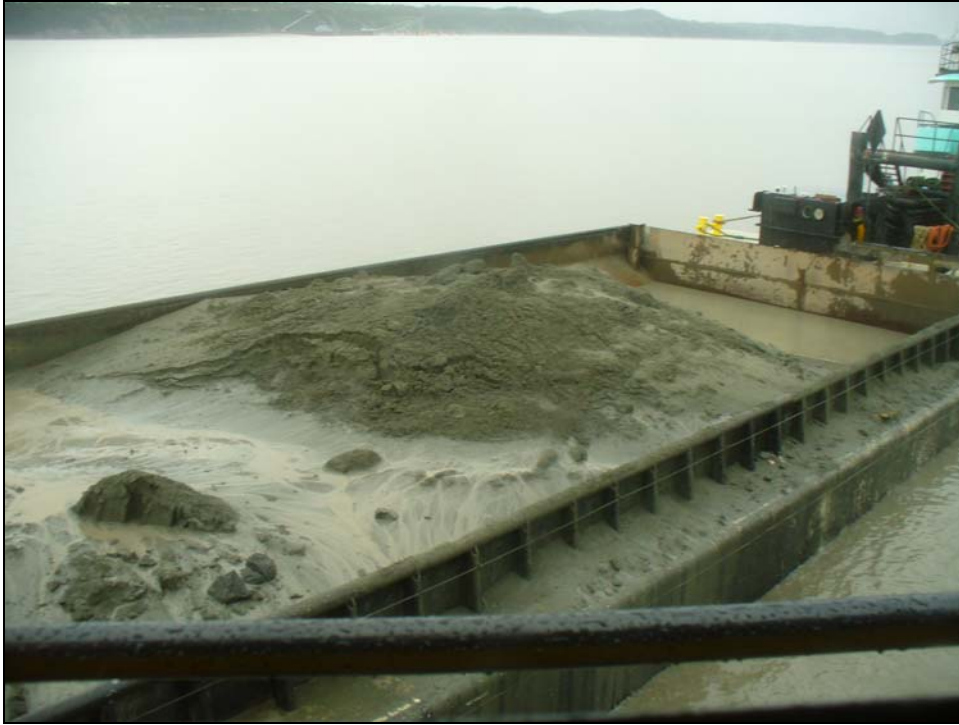
Photograph 13: Poorly graded sand with silt (SP-SM) encountered at trial dredge area 1 (AP-4607).

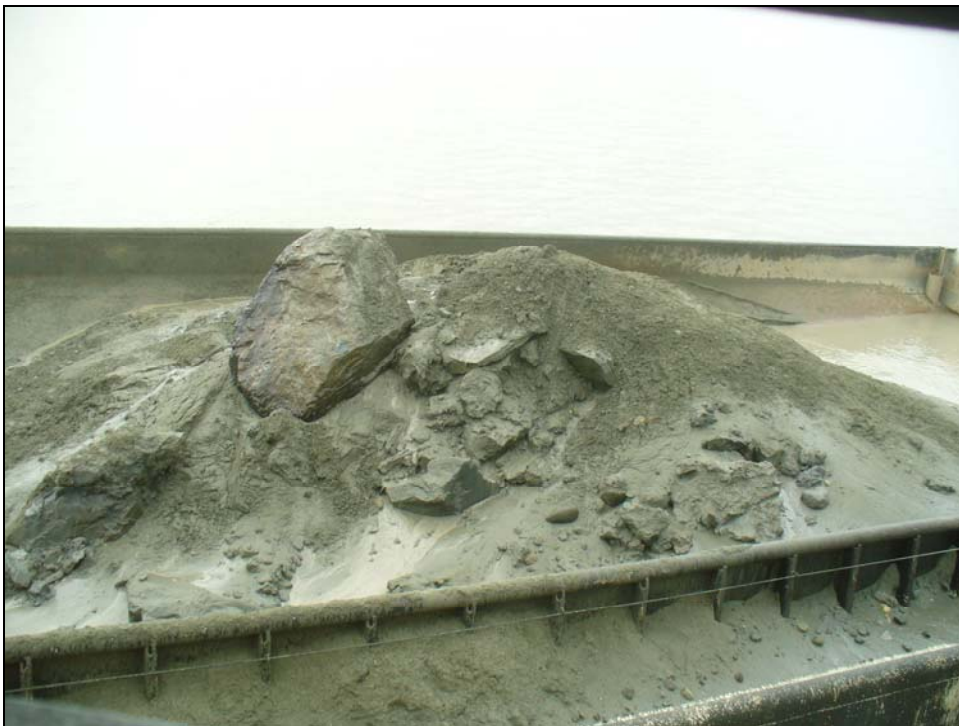
Photograph 14: Boulders encountered while dredging at trial dredge area 1 (AP-4607).

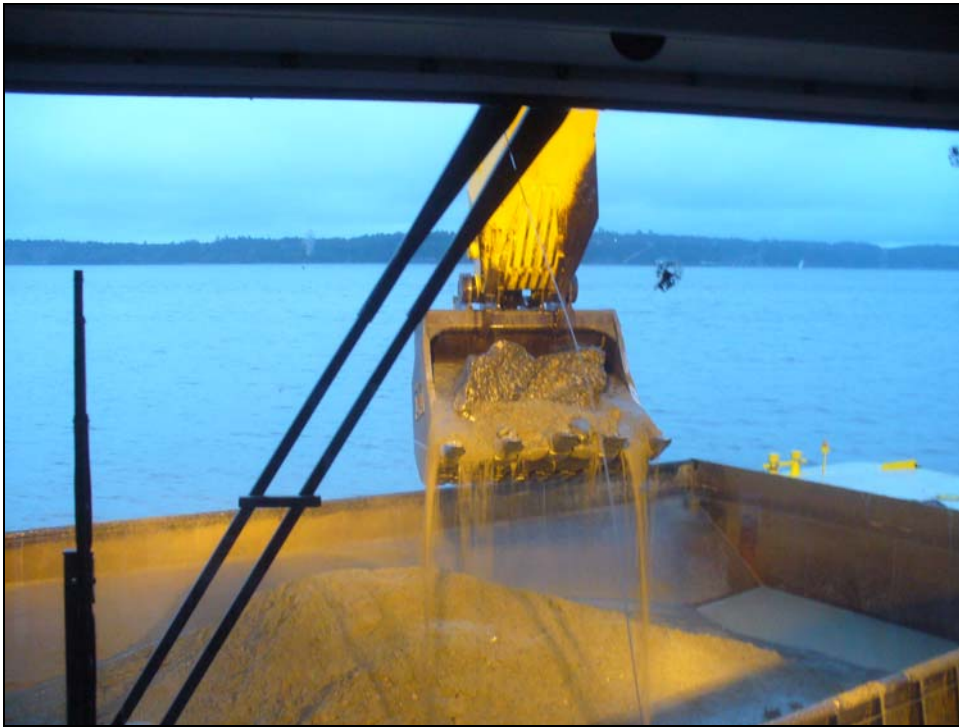
Photograph 15: Boulder encountered while dredging at trial dredge area 1 (AP-4607).

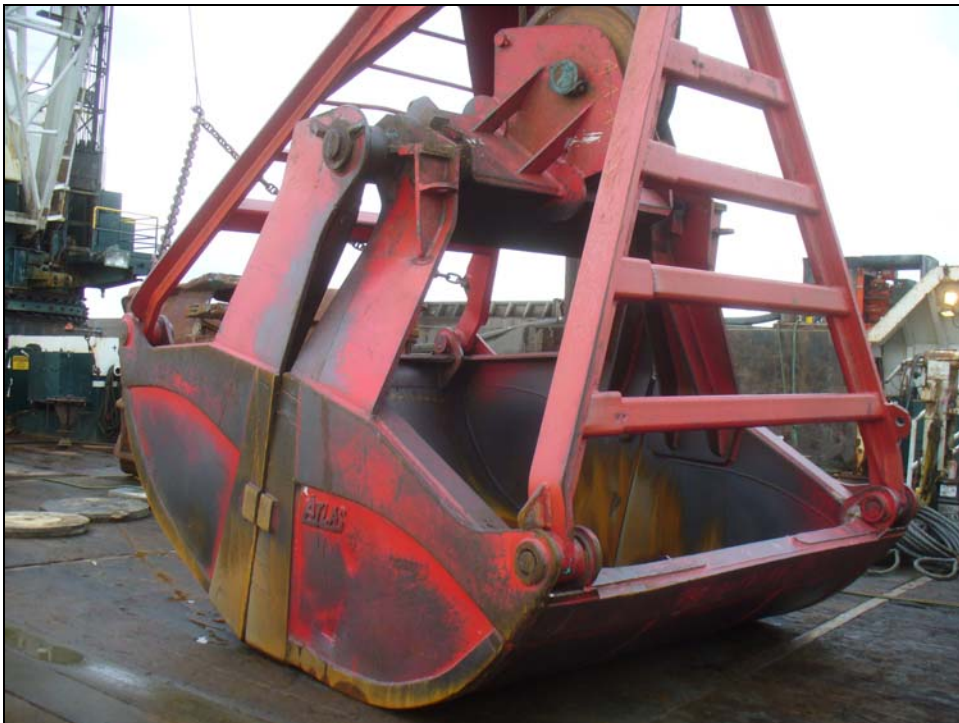
Photograph 16: Dutra's 20-cubic yard Atlas clam-shell bucket weighing 30,000 pounds.

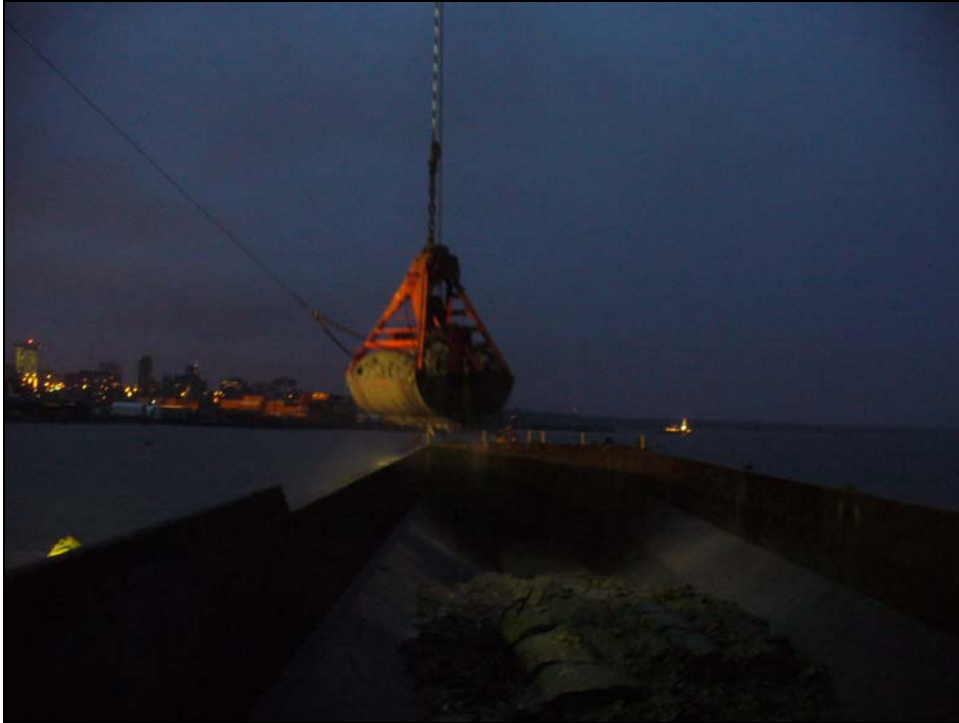
Photograph 17: Dutra's 20-cubic yard Atlas clam-shell bucket heaped with soft marine deposits at trial dredge area 2 (AP-4611).

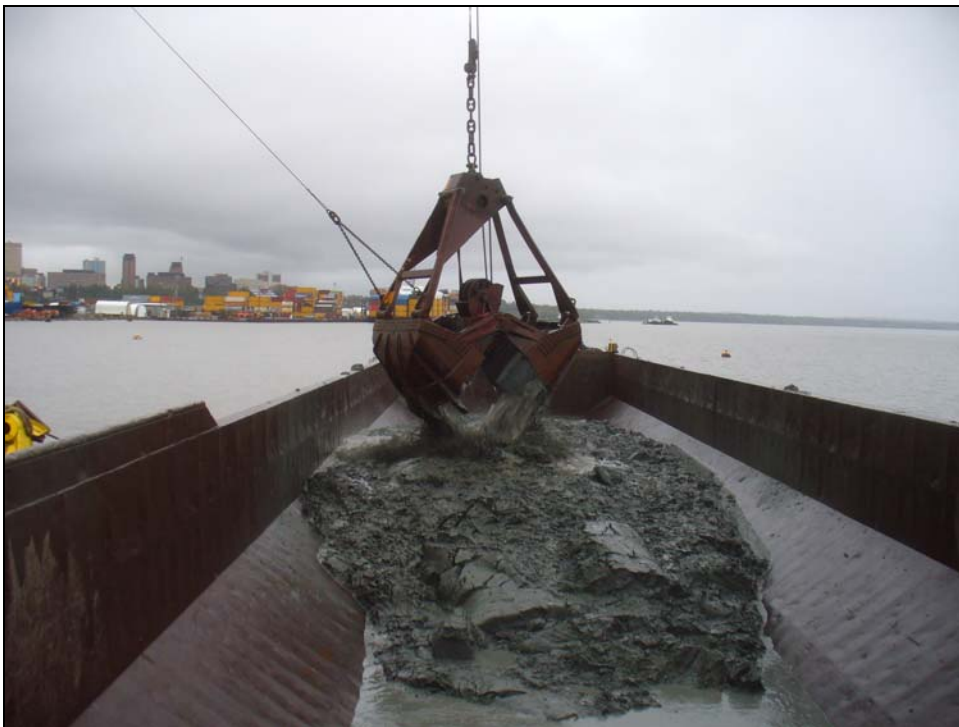
Photograph 18: Example of low recovery using the 10-cubic yard Owens bucket at trial dredge area 2 (AP-4611).

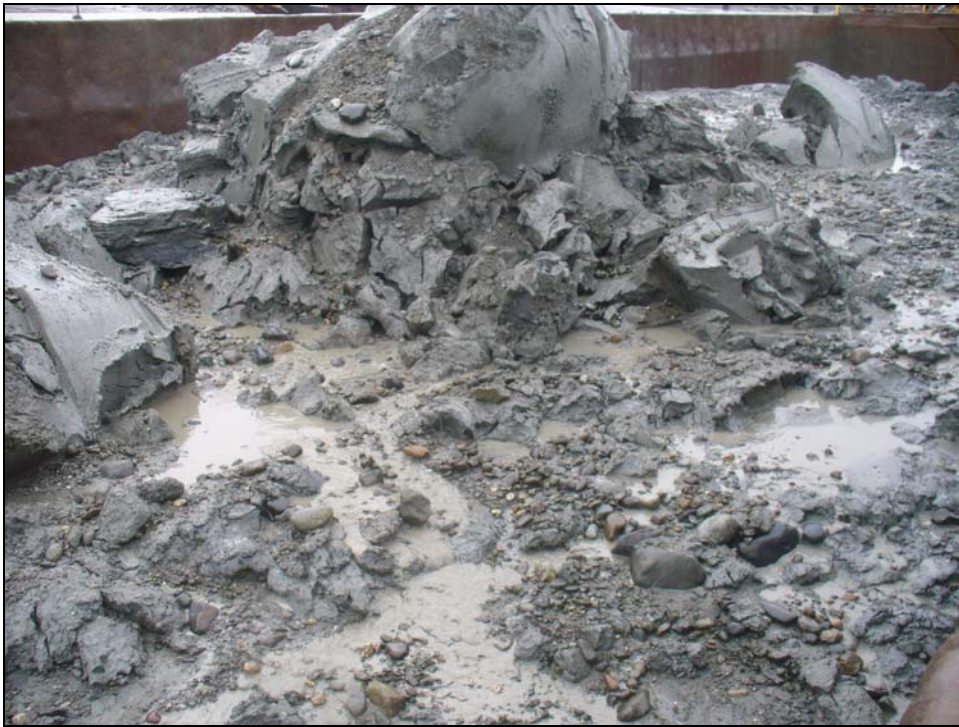
Photograph 19: Clayey gravel with sand and cobbles (GC) dredged at trial dredge area 2 (AP-4611).

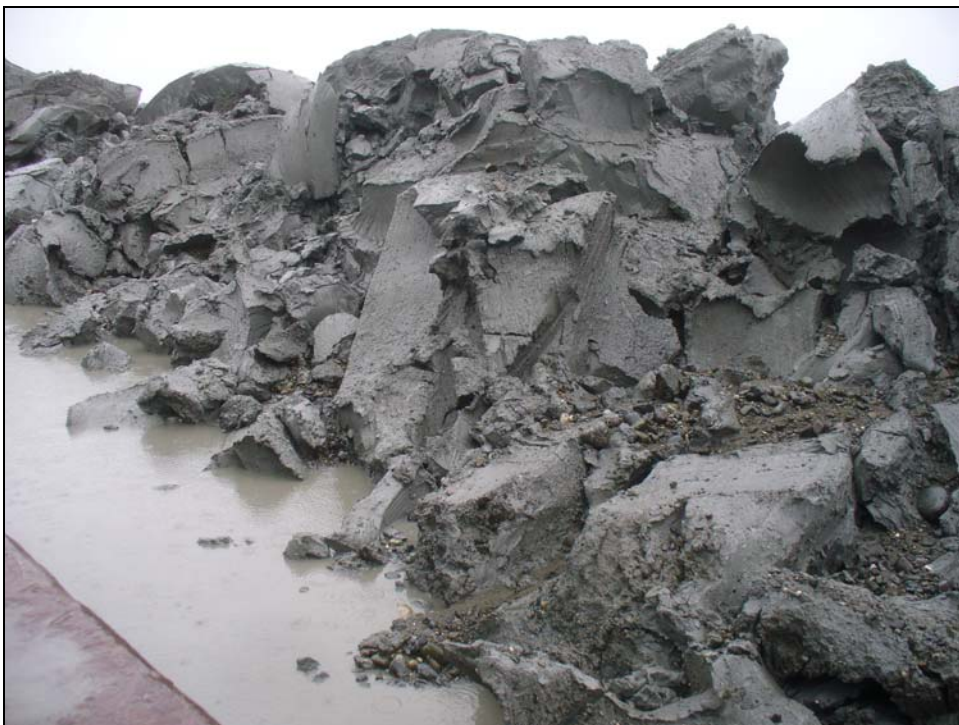
Photograph 20: Lean clay (CL) dredged at trial dredge area 2 (AP-4611).

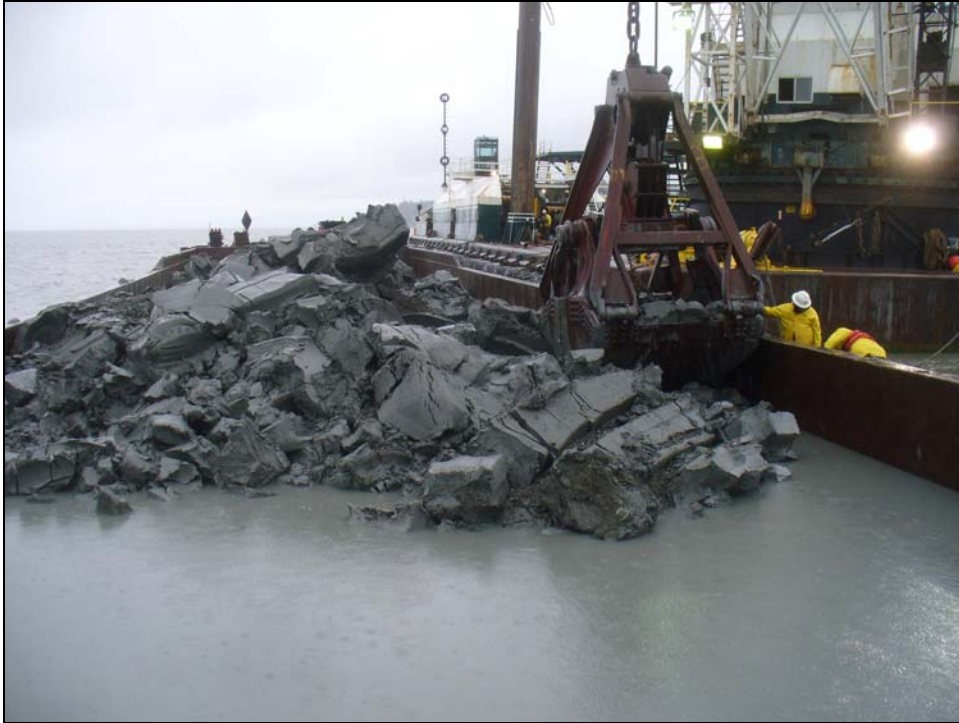
Photograph 21: Lean clay (CL) dredged at trial dredge area 2 (AP-4611).

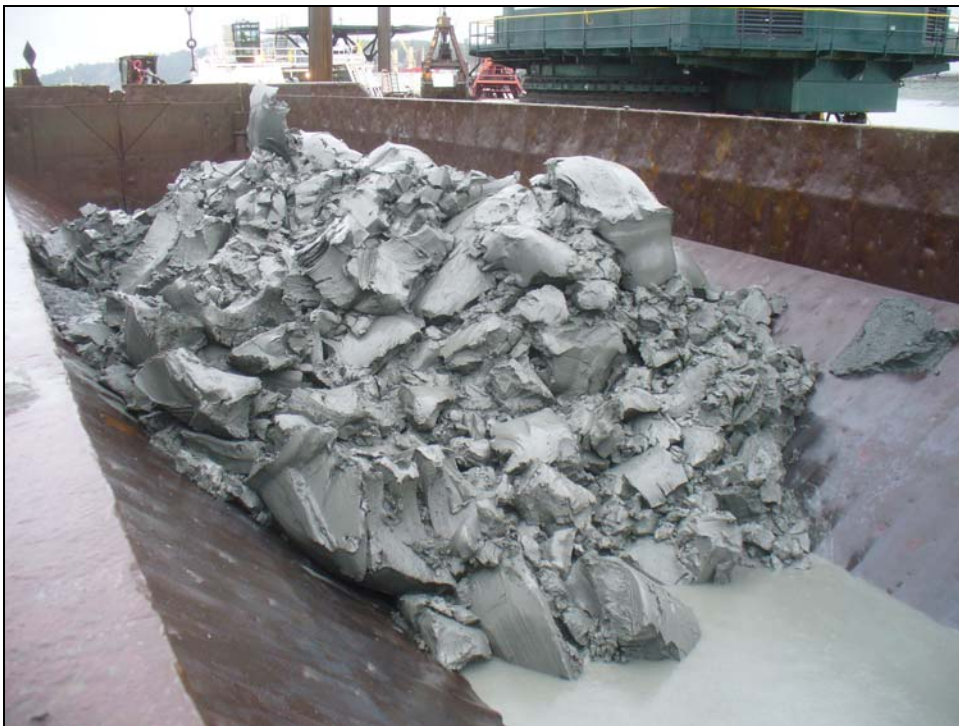
Photograph 22: Lean clay (CL) dredged at trial dredge area 2 (AP-4611).

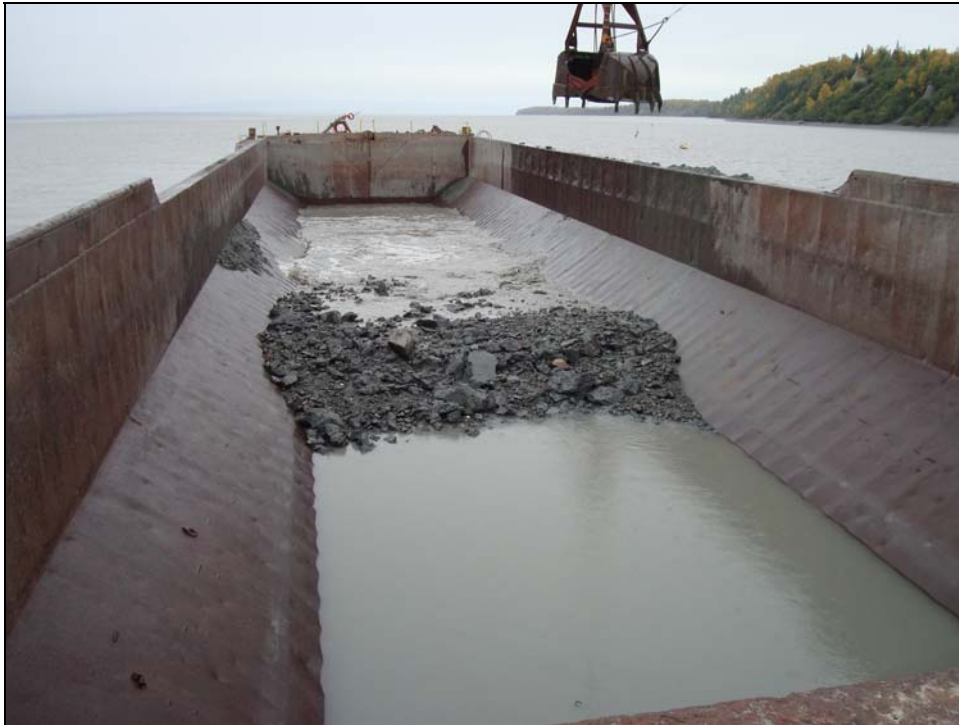
Photograph 23: Poorly graded gravel with silt, sand and cobbles (GP-GM) dredged at trial dredge area 3 (AP-4590).

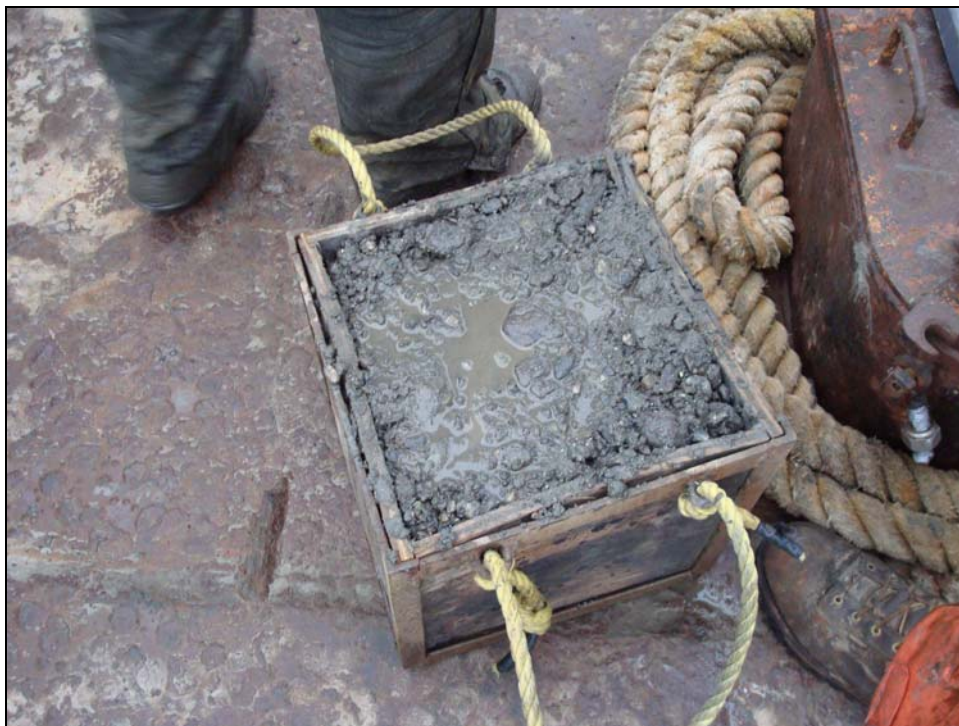
Photograph 24: Poorly graded gravel with silt, sand and cobbles (GP-GM) (148.4 pounds per cubic foot) dredged at trial dredge area 3 (AP-4590).
